**Flood Control Project Maintenance
Levee Inspections**

Fall 2010 Levee Maintenance Deficiency Summary Report

San Joaquin River Basin

Reclamation District No. 2085 Kasson

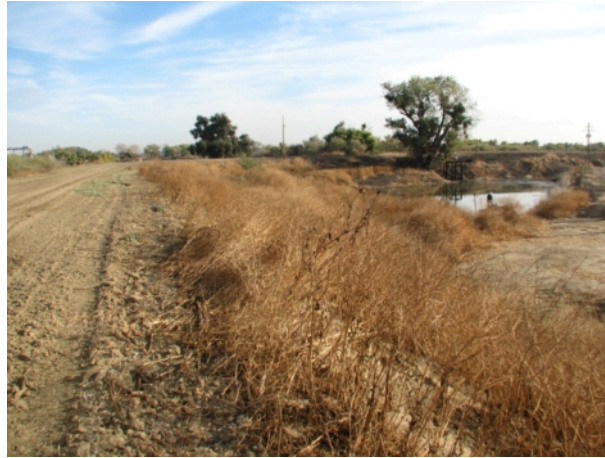
jpaasch_f_20101028_496.jpg

Levee Mile Report Line	2
Start Levee Mile	0.45
End Levee Mile	0.46
Location	Land Side
Category	Earthen Levee
Item	Vegetation

Tall weeds remain on the landside levee slope.

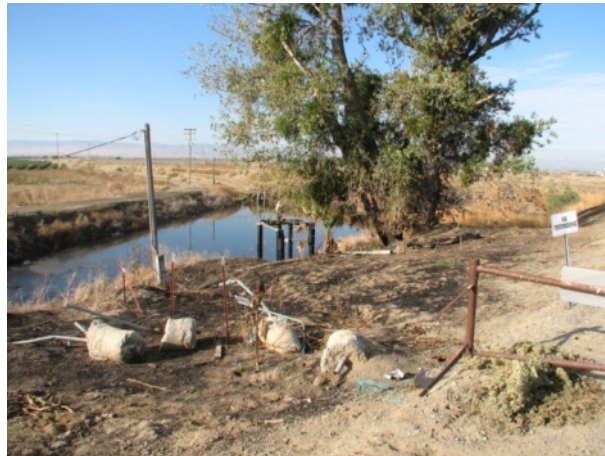
jpaasch_f_20101028_497.jpg

Levee Mile Report Line	3
Start Levee Mile	0.47
End Levee Mile	0.47
Location	Water Side
Category	Earthen Levee
Item	Encroachments

Drainage discharge pipe penetrates levee with no closure devices.

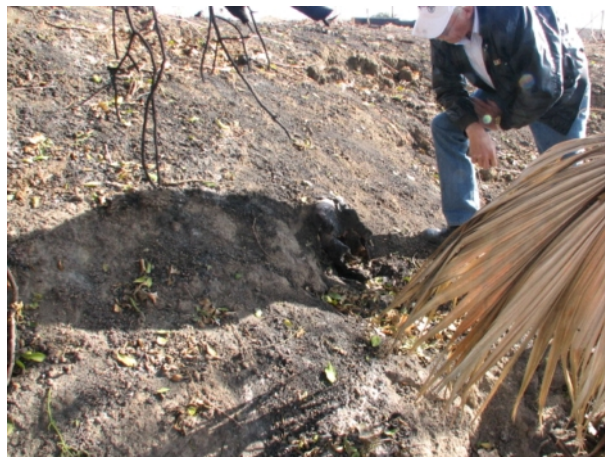
jpaasch_f_20101028_498.jpg

Levee Mile Report Line	3
Start Levee Mile	0.47
End Levee Mile	0.47
Location	Water Side
Category	Earthen Levee
Item	Encroachments

Opening on landside appears to consists of melted poly pipe halfway up levee slope. Opening on waterside is heavily corroded steel pipe.

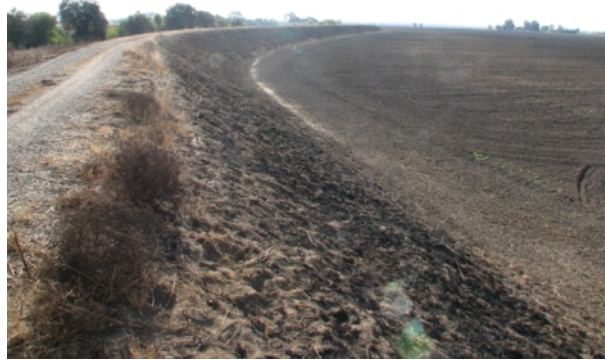
jpaasch_f_20101028_499.jpg

Levee Mile Report Line	7
Start Levee Mile	0.89
End Levee Mile	1.18
Location	Land Side
Category	Earthen Levee
Item	Encroachments

Tilling of soil on the levee toe will destabilize the slope over time.

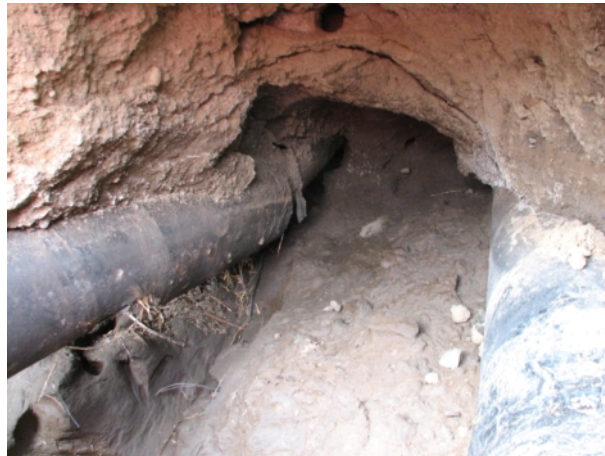
jpaasch_f_20101028_500.jpg

Levee Mile Report Line	9
Start Levee Mile	1.28
End Levee Mile	1.28
Location	Crown
Category	Earthen Levee
Item	Encroachments

Photo of damage to levee prism caused by leaking pipe(s).

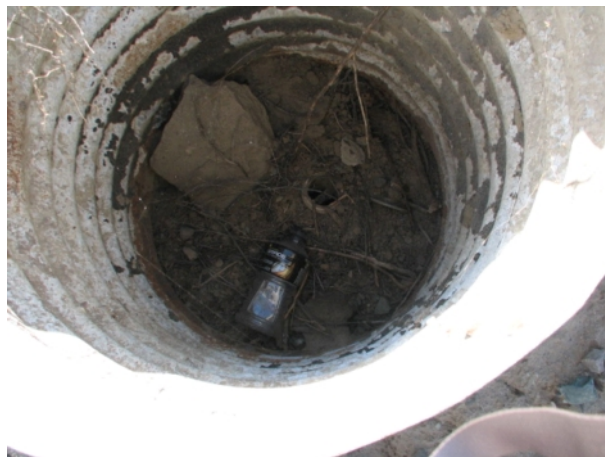
jpaasch_f_20101028_501.jpg

Levee Mile Report Line	11
Start Levee Mile	1.35
End Levee Mile	1.35
Location	Crown
Category	Earthen Levee
Item	Encroachments

Photo of anti siphon at waterside shoulder.

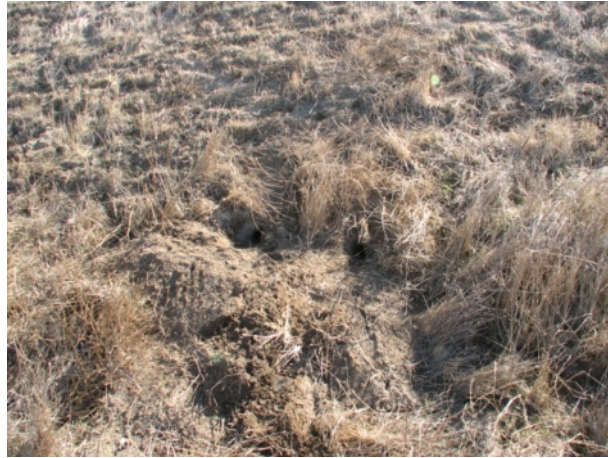
jpaasch_f_20101028_502.jpg

Levee Mile Report Line	23
Start Levee Mile	3.24
End Levee Mile	3.24
Location	Land Side
Category	Earthen Levee
Item	Animal Control

Rodent holes have been flagged for repair.

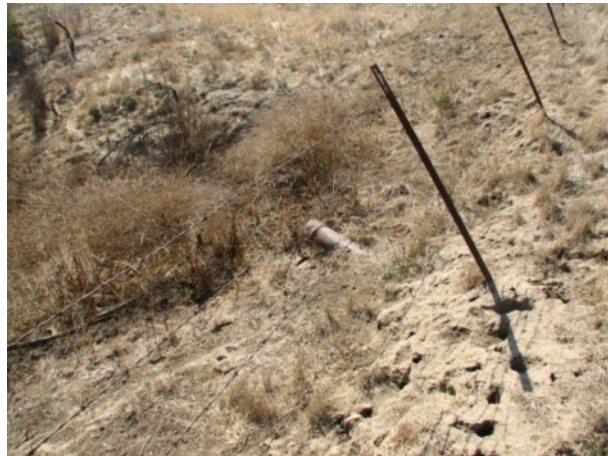
jpaasch_f_20101028_504.jpg

Levee Mile Report Line	24
Start Levee Mile	3.24
End Levee Mile	3.24
Location	Water Side
Category	Earthen Levee
Item	Encroachments

Photo of pipe penetration discharge off landside slope.

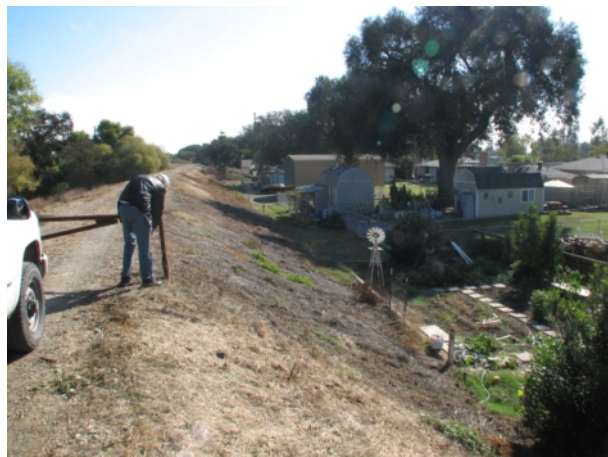
jpaasch_f_20101028_505.jpg

Levee Mile Report Line	32
Start Levee Mile	4.32
End Levee Mile	4.37
Location	Land Side
Category	Earthen Levee
Item	Encroachments

Updated photo of encroachments on landside toe.

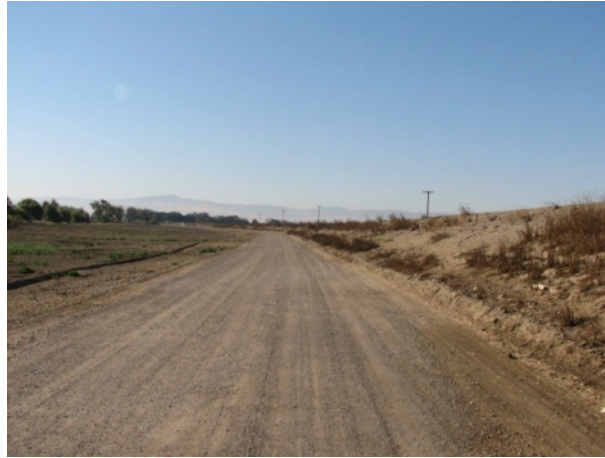
Levee Mile Report Line	1
Start Levee Mile	0.01
End Levee Mile	0.69
Location	Water Side
Category	Earthen Levee
Item	Vegetation
Some weeds on levee slope are present and partially obstruct visibility.	
jpaasch_f_20101028_508.jpg

LMR No.	Levee Mile		Category	Item	* Location	** Rating	Action/Comment	GPS Latitude/Longitude		Issue No. Photo
	Start	End						Start	End	
1	0.01	0.69	Earthen Levee	Vegetation	WS	M	Remove the wild growth other than native grasses from the levee slopes. Inspector Comments: Wing levee into SJR floodway.	37.705018 ° -121.274598 °	37.714039 ° -121.269665 °	1 Y

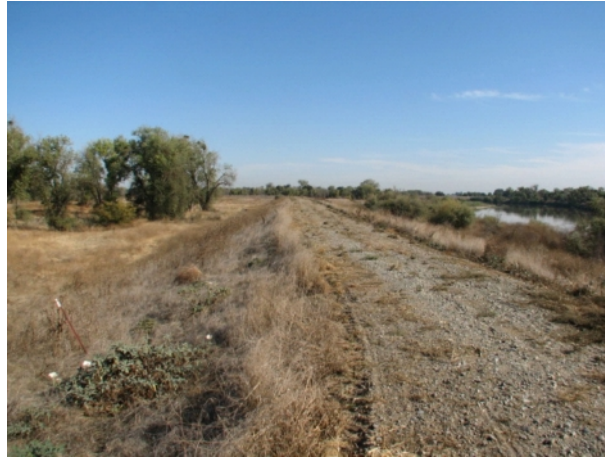
jpaasch_f_20101028_509.jpg

Levee Mile Report Line	1
Start Levee Mile	0.01
End Levee Mile	0.29
Location	Water Side
Category	Earthen Levee
Item	Vegetation

Unwanted weed growth on levee slopes.

LMR No.	Levee Mile		Category	Item	* Location	** Rating	Action/Comment	GPS Latitude/Longitude		Issue No.
	Start	End						Start	End	Photo
1	0.01	0.29	Earthen Levee	Vegetation	WS	M	Remove the wild growth other than native grasses from the levee slopes.	37.680604 ° -121.264501 °	37.683928 ° -121.261921 °	4 Y
